This document describes firmware changes for:

"Lynx Ion 350"

"Lynx Ion + Shunt350"

"Lynx Ion + Shunt 600"

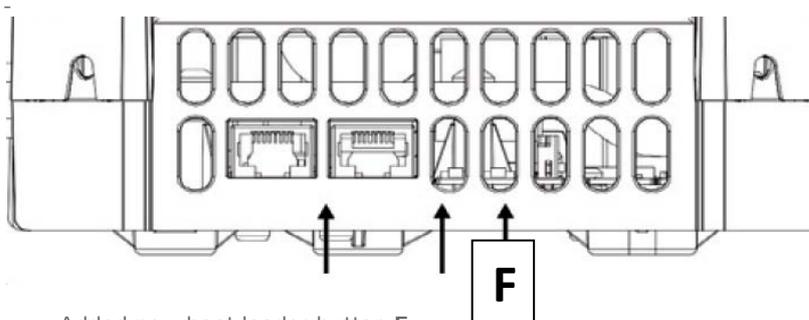
- Added new boot loader button F
If incorrect software is programmed, this button can be used to startup the boot loader again. Button can also be used to go to boot loader directly. If the device is in sleep mode and then the button is pressed for 2 seconds, device will start up in boot loader mode. This way the device is not required first to start up in normal mode.
NOTE: when device has been in boot loader mode, new software has been loaded or not, first press the Start button for 3 seconds to get it out of boot loader mode.
- Fixed bug in device settings.
- Fixed bug in history value storage.
- Updated device hardware version handling on VE-Can
- Updated charger detection, when charger detected device can also be started directly with the start button.
